# Product Theft on Pipelines: How to Detect and Locate Illegal Tapings

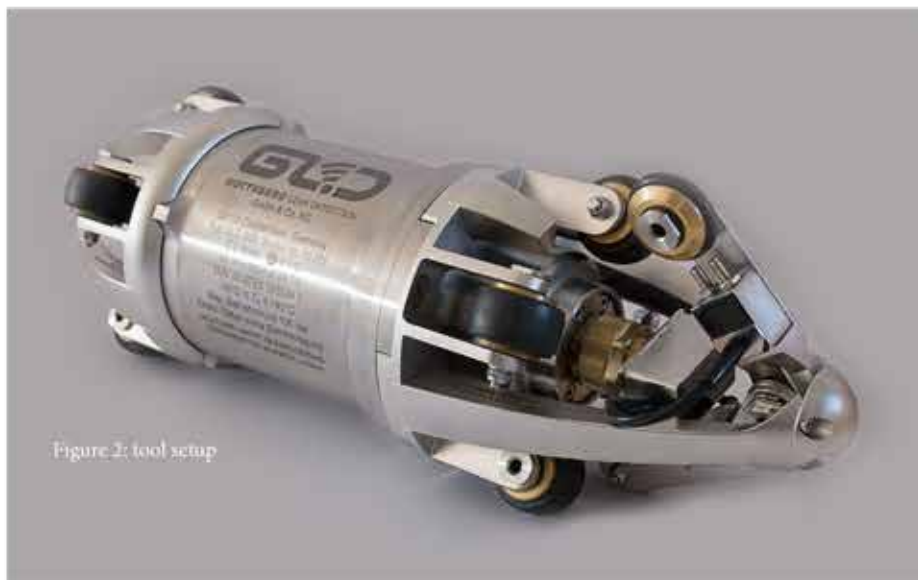
Figure 2: tool setup

For the trial a GLD 202 leak detector with standard configuration had been used. (Figure 2) The tool is working on an acoustic basis, recording all noises during the pipeline run. The sound data is processed and a frequency analysis is performed to make statements about the origin of a signal.

The chassis for the electronics had been slightly modified to suit for that special pipeline and guarantee a safe and quiet locomotion for best run results.

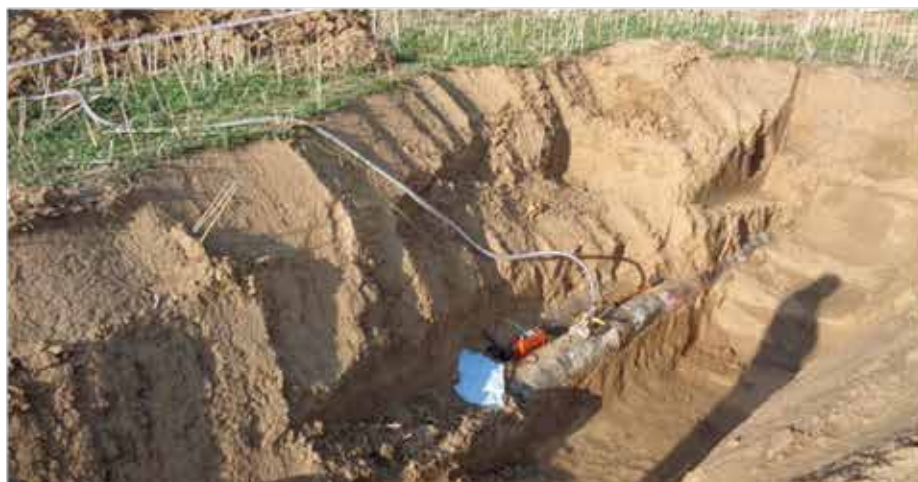
Figure 4

### Leakage 2 setup: (Figure 4)

An already existing construction pit had been used to setup leak 2. A ball valve DN25 and drilled with a 6 mm drill to the main pipeline. Leak flow reduction done via ball valve DN25 partly opened, leak flow was 0,57 m<sup>3</sup>/hr, 9,5 l/min

Again the leak could be verified by sound frequencies that, compared to leak one have shifted a little bit to lower frequencies around 10 to 20 kHz and with lower amounts at the higher ranges. Additional verification could be done through signal geometry. Location accuracy was again just a few meters +/-.

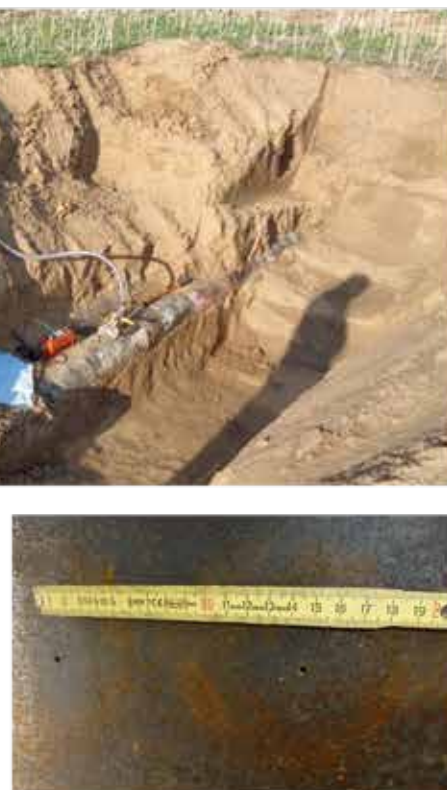
Figure 5

In the past Gottsberg Leak Detection tools have detected many locations where

criminals had been stealing product and the treatment of the pipe wall differs a lot from big holes of 2 cm to plenty of small holes of less than 5 mm to avoid being detected with intelligent pigging by staying below the threshold of these tools.
